Sonoran Property Inspections

Property Inspection Report

7639 E Traders Trail, Prescott Valley AZ, 86314
Inspection prepared for: Jerry Spicer
Inspection Date: 6/10/2016 Time: 9:00 am to 12:30 pm
Age: 2007 Size: 2210
Weather: Cloudy 74 degrees

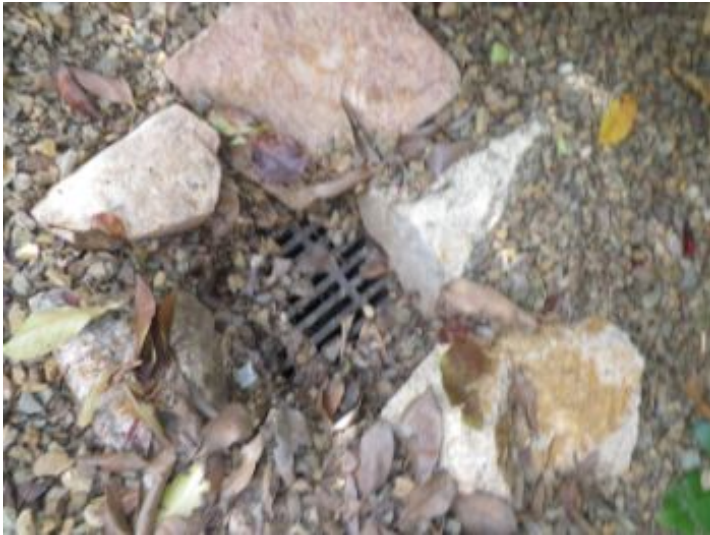
There are additional site drains installed to help manage water flow. These drains are not tested and I don't know where they are connected to. These drains are installed to help manage water flow. I recommend having a plumber run a camera through them to determine if they are clogged and where they are connected.

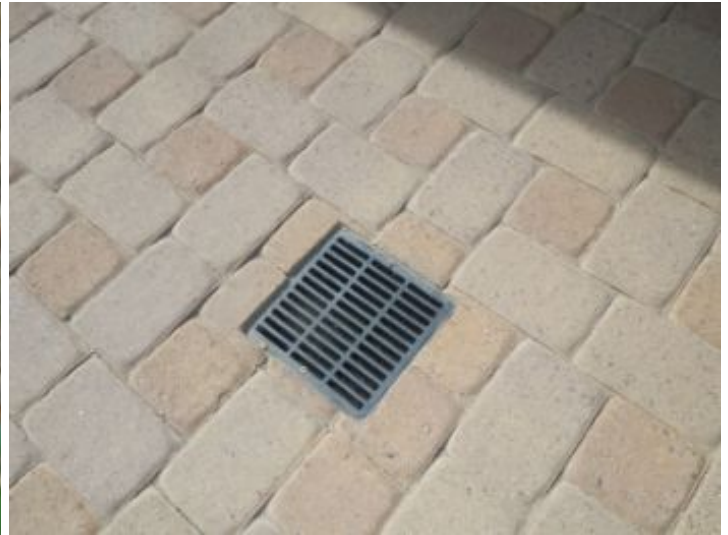
There are additional site drains installed to help manage water flow. These drains are not tested and I don't know where they are connected to. These drains are installed to help manage water flow. I recommend having a plumber run a camera through them to determine if they are clogged and where they are connected.

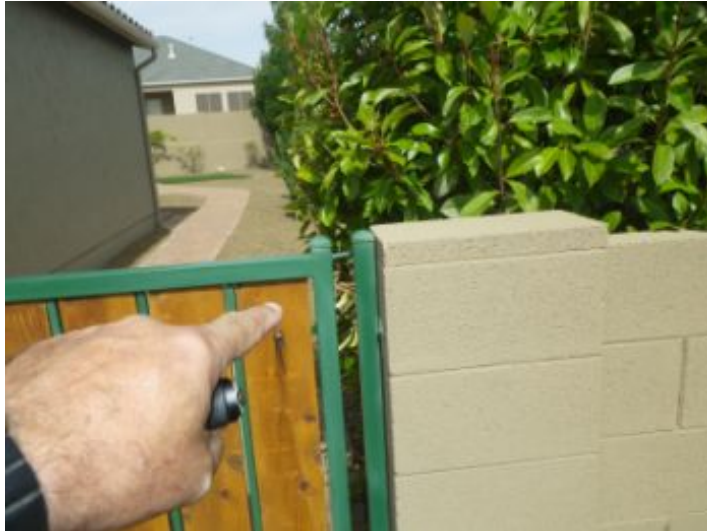
Hard to operate and close- recommend adjustments

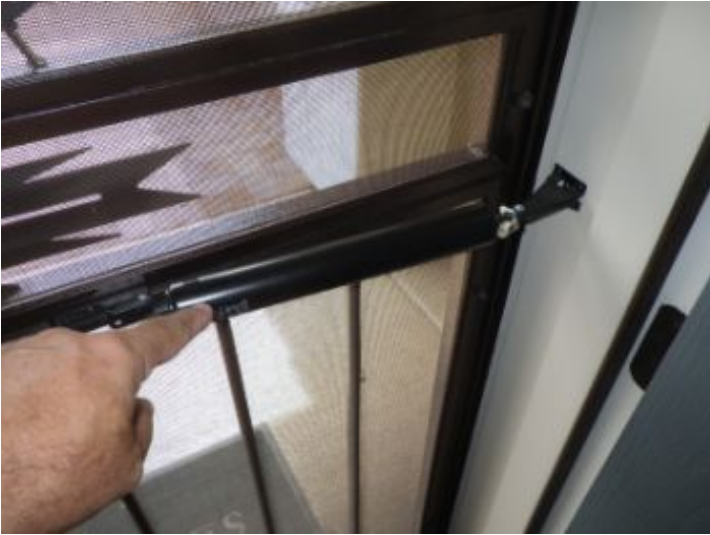
Entry screen door self closer needs adjustments or replacing to operate correctly

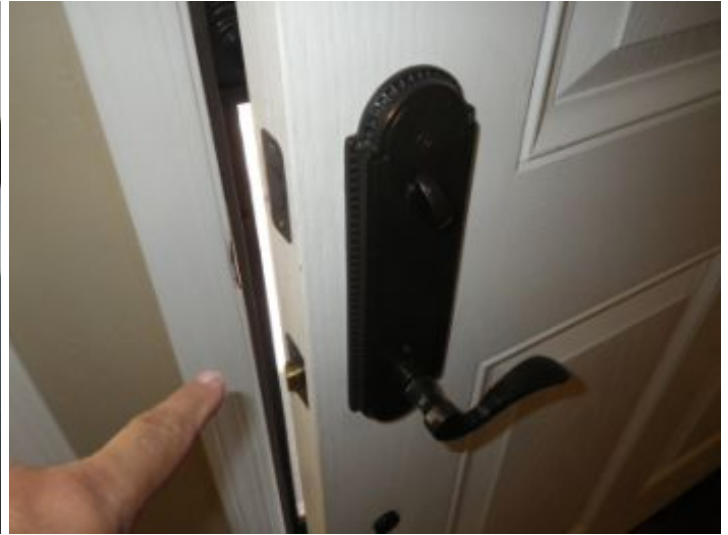
Front door does not latch, recommend adjustments for safety

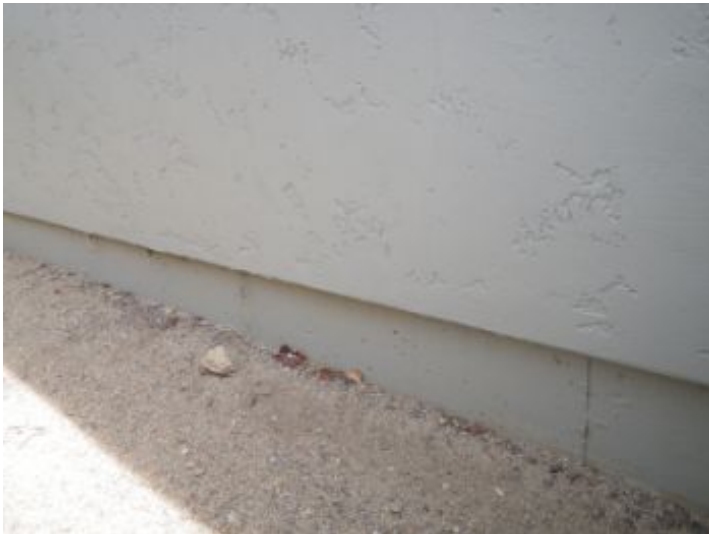
excellent detail at perimeter of stem

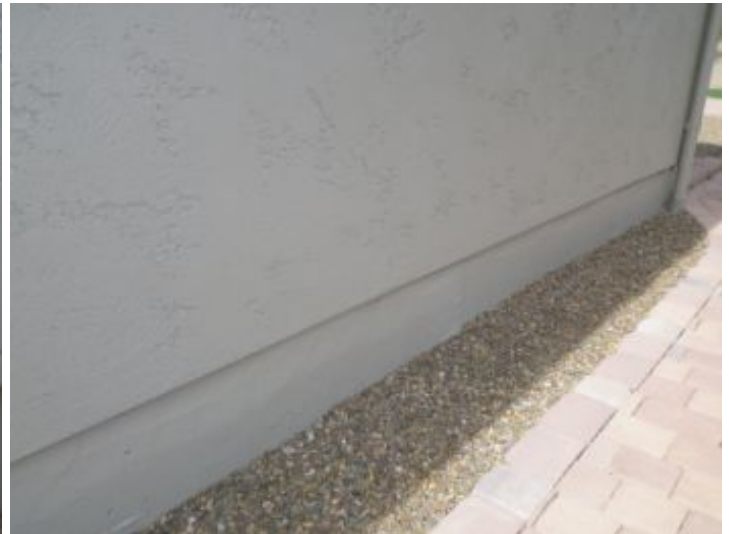
excellent detail at perimeter of stem

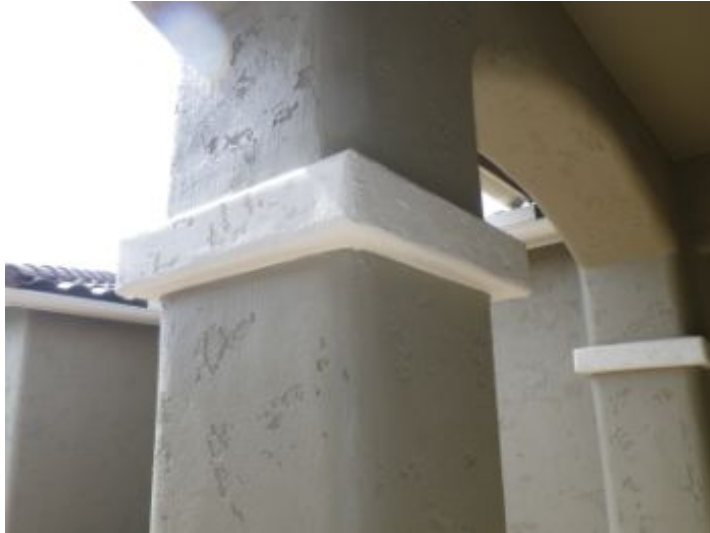
Support column is not visible due to wood frame and stucco, what is visible appears to be in acceptable condition @ front and rear of home

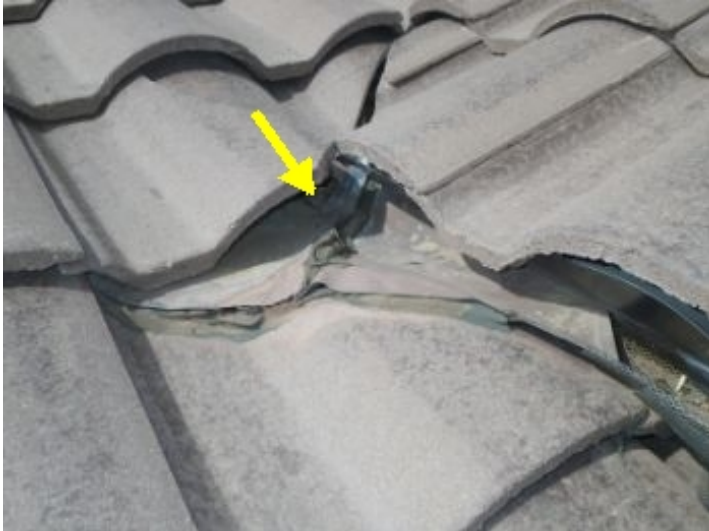
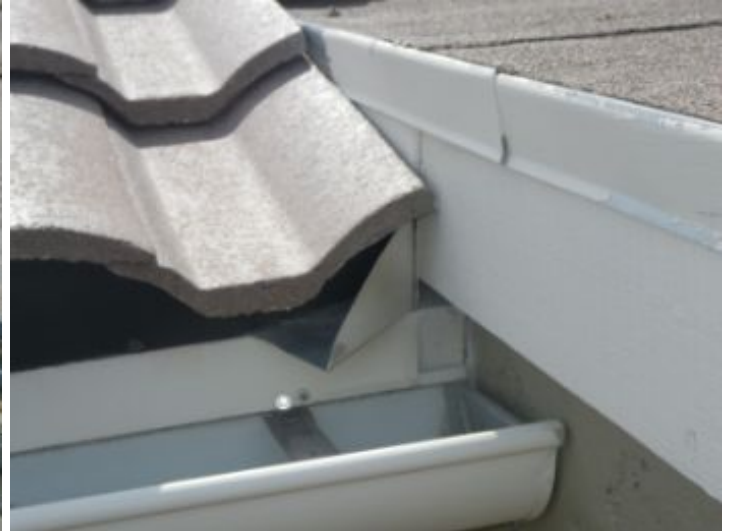
Valley flashing at both areas upper left of entry needs correction, there is a belly in the flashing and the flashing needs to be extended , this will trap water and potentially cause a leak.

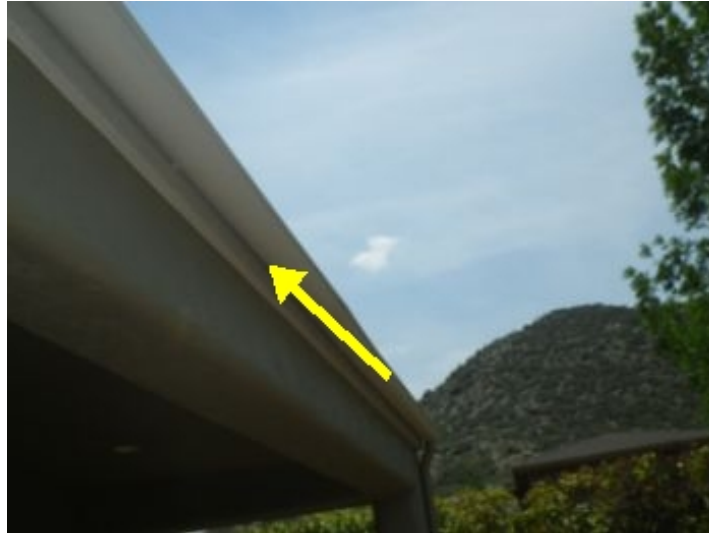
Rear patio cover gutter is not supported properly and will flex when full of water, this needs to be supported correctly or have 2 sections of gutter across the back rather than 1. Recommend a licensed Gutter Contractor evaluate and repair

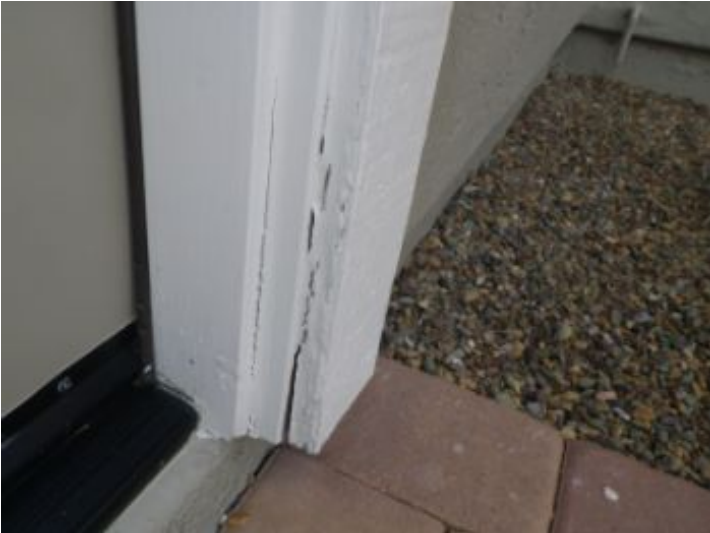
Recommend caulking and re painting the lower section of rear exterior garage jamb

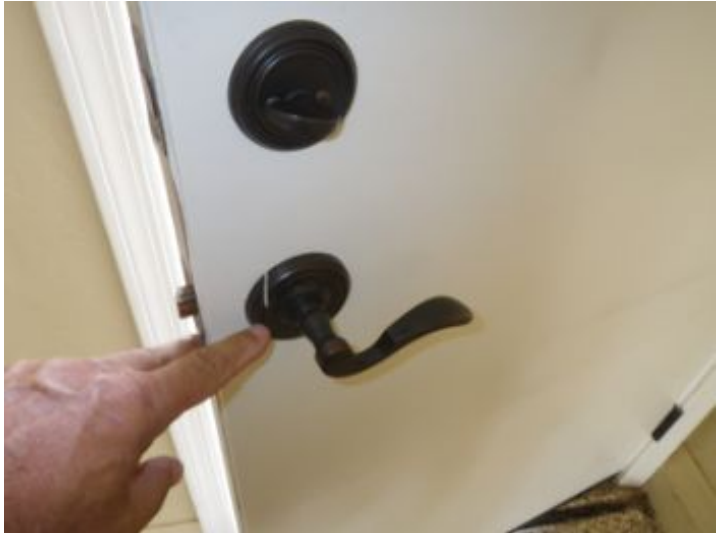
Garage exterior door knob needs adjustments

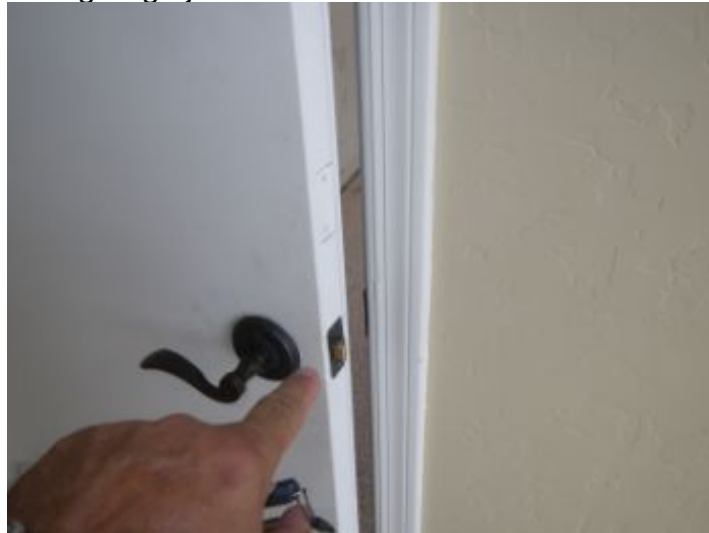
Strike plate needs adjustment to properly secure the door. @ single car garage

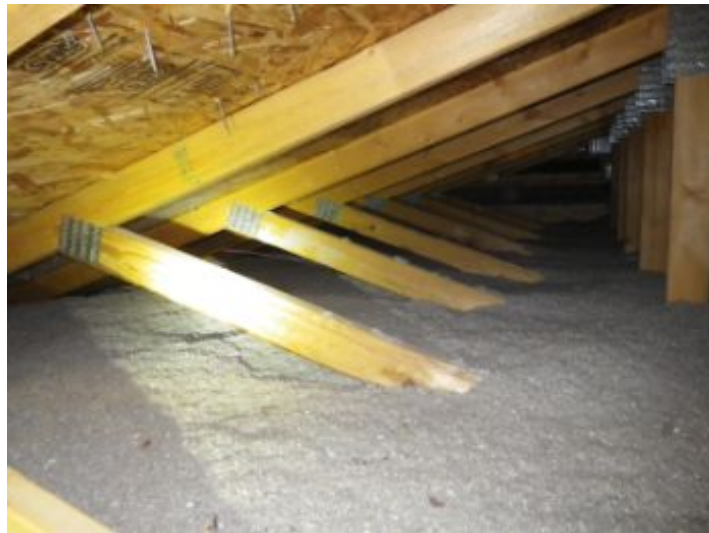
I am not able to get to all corners of this attic, what is visible appears to be in acceptable condition. If this is a concern, I recommend discussing with a Licensed Architect or a Structural Engineer.

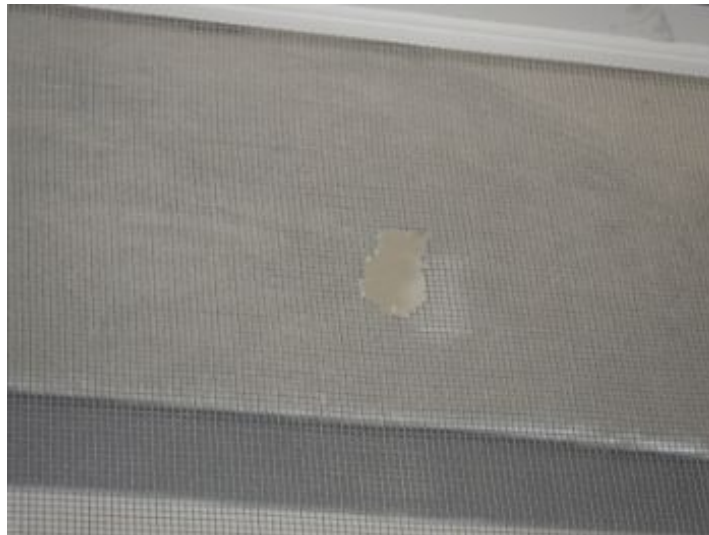
Torn screen at single car garage window, this will need to be re screened.

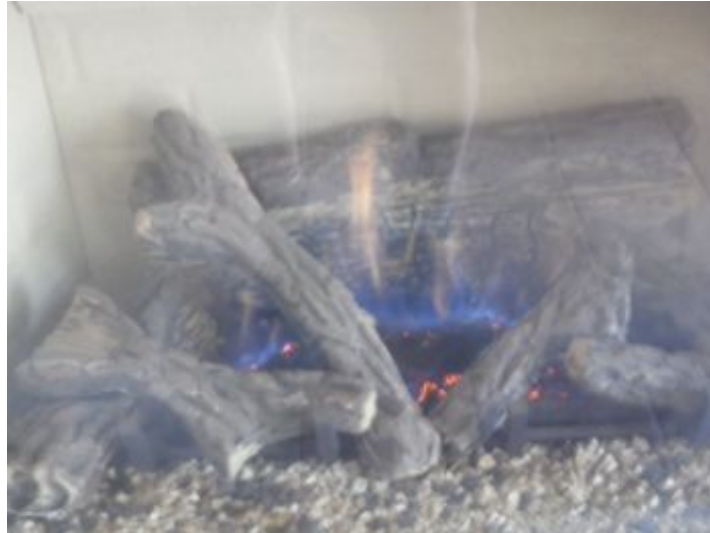
Fireplace is present and appears in good condition

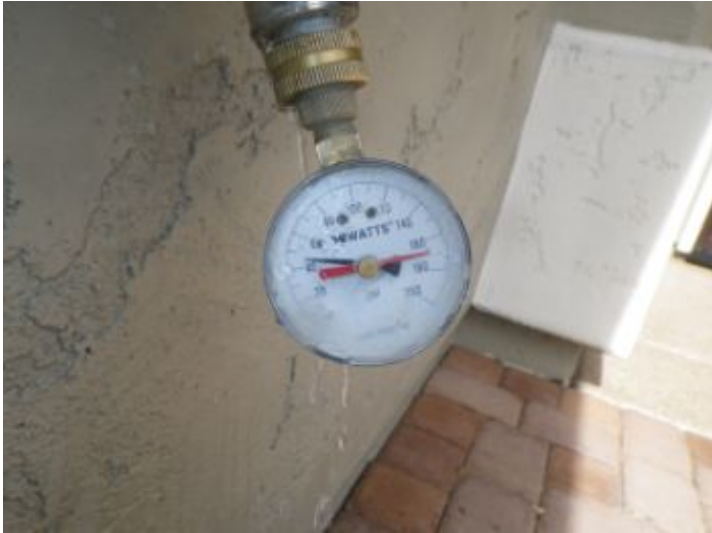
50 psi

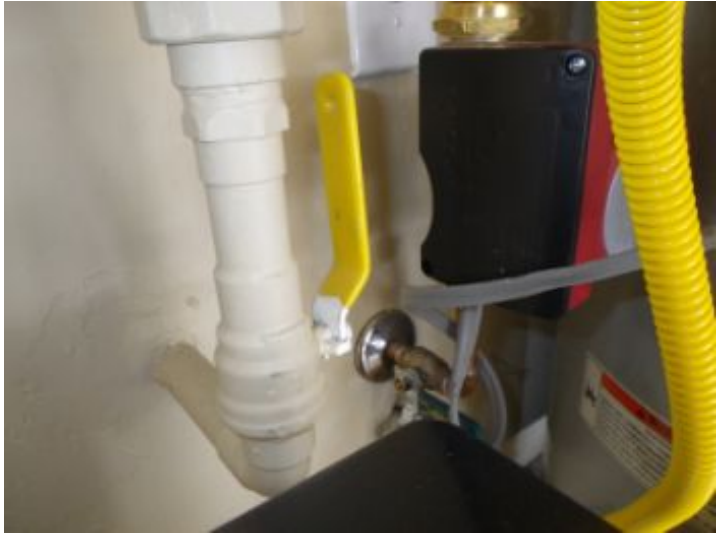
Water shut off in the garage, excellent

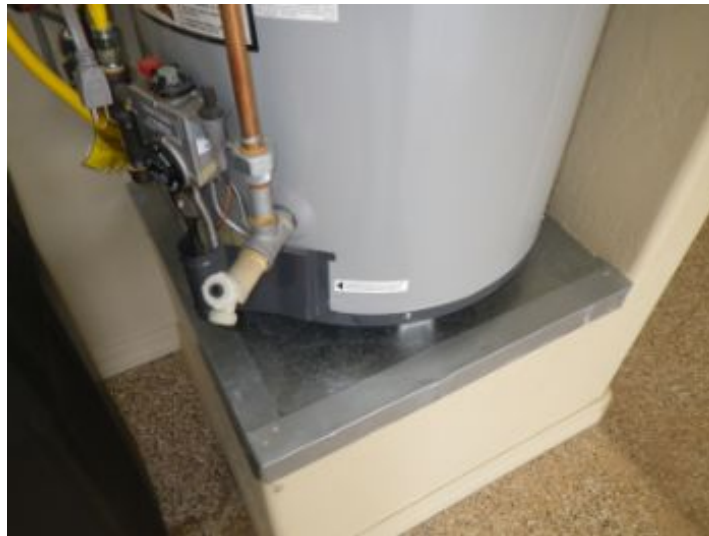
- Water heater is an older model and quite possibly at the end of its life. Recommend replacing this unit before there is a major failure and water damage occurs.

Recommend adding a catch pan/ drain pan under the water heater. In the event of a water heater leak, this can save potential damage to the interior living space adjacent to the water heater.

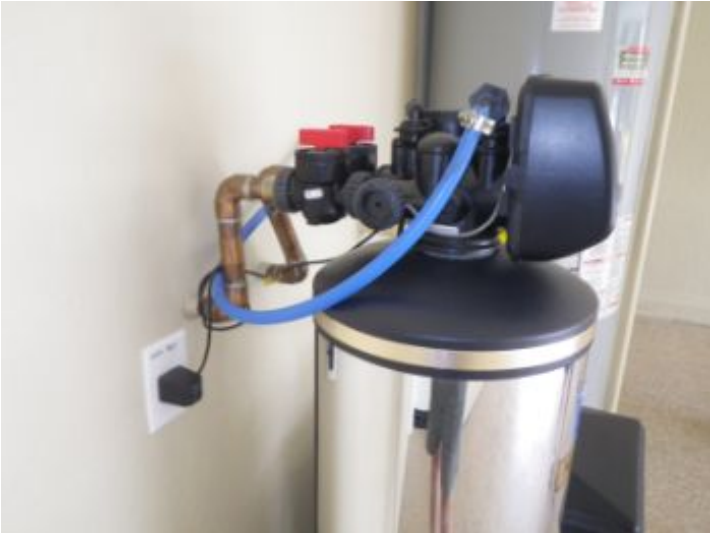
When running cold side water at all water using devices there is heavy rusty water, since it's only the cold side it's possible this can be a water softener issue, Recommend a Licensed plumber evaluate and repair. It's also possible the water softener will need flushing and sanitized.

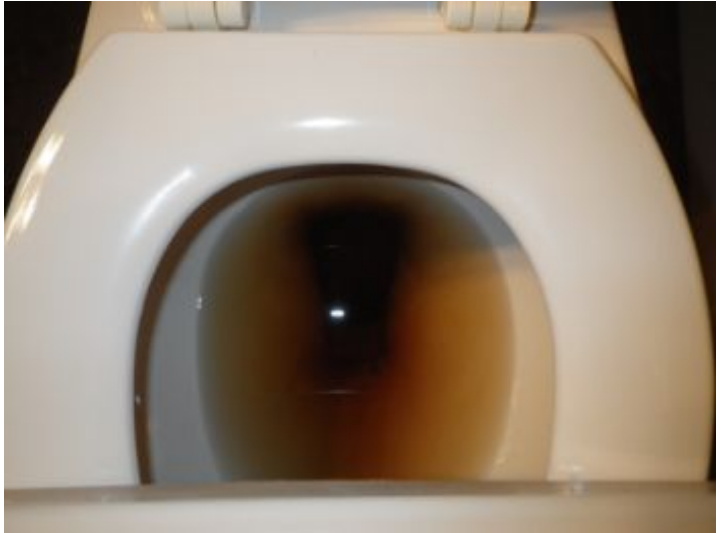
When running cold side water at all water using devices there is heavy rusty water, since it's only the cold side it's possible this can be a water softener issue, Recommend a Licensed plumber evaluate and repair. It's also possible the water softener will need flushing and sanitized.

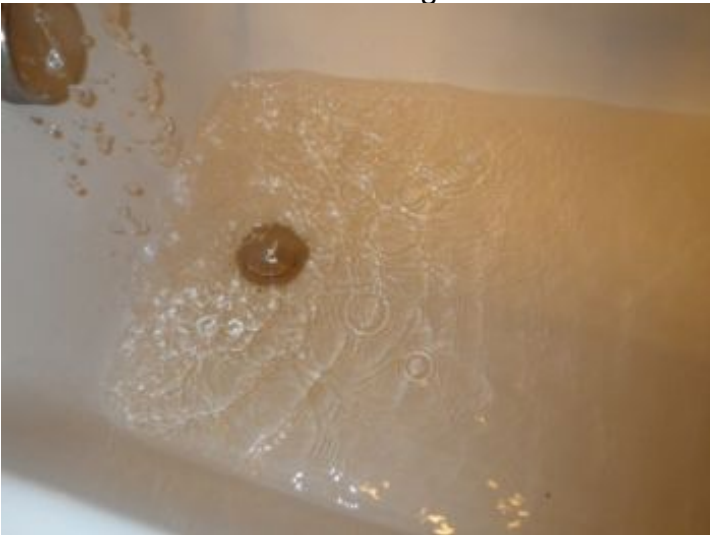
When running cold side water at all water using devices there is heavy rusty water, since it's only the cold side it's possible this can be a water softener issue, Recommend a Licensed plumber evaluate and repair. It's also possible the water softener will need flushing and sanitized.

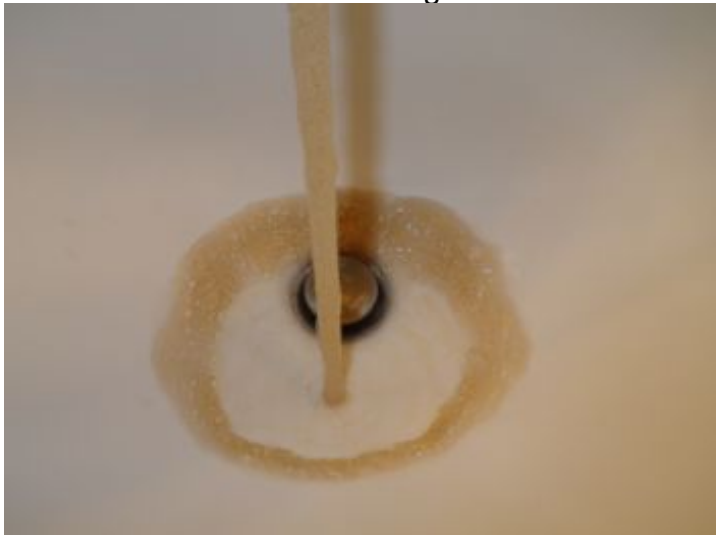
When running cold side water at all water using devices there is heavy rusty water, since it's only the cold side it's possible this can be a water softener issue, Recommend a Licensed plumber evaluate and repair. It's also possible the water softener will need flushing and sanitized.

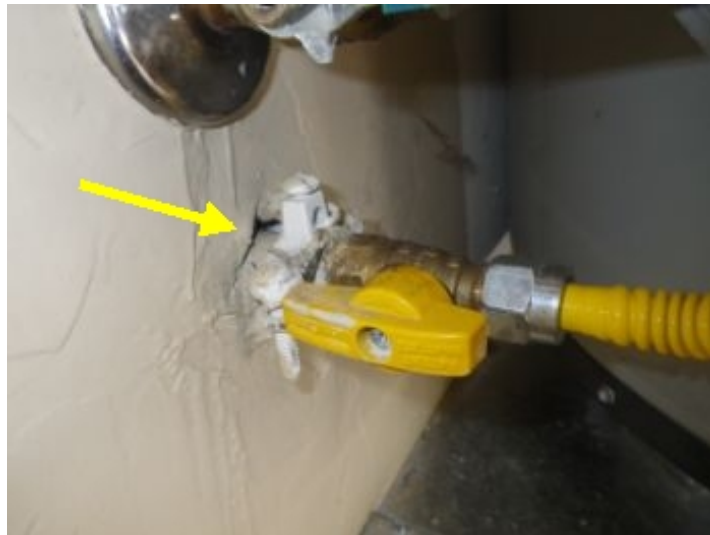
Bond wire visible at gas piping

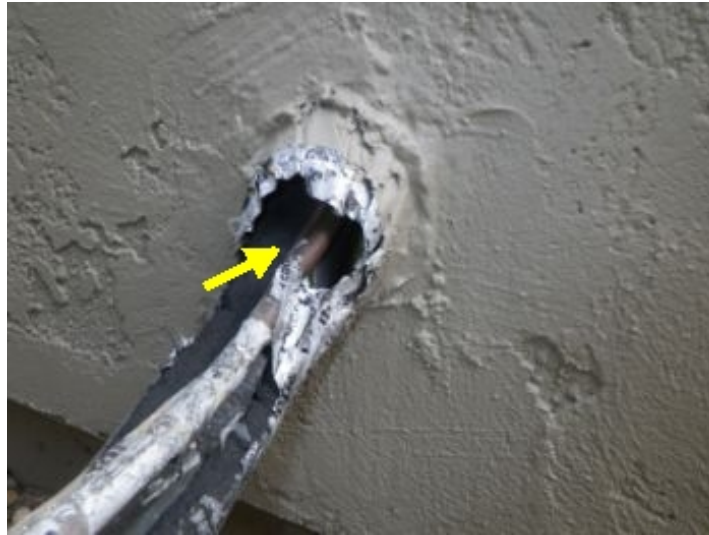
recommend sealing the condensing line set opening into the wall with foam so pest don't enter.

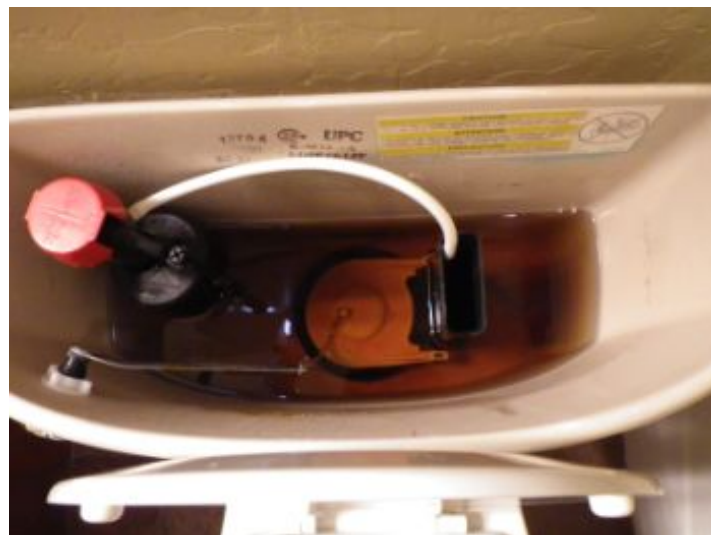
See note in General Plumbing section on Rusty water

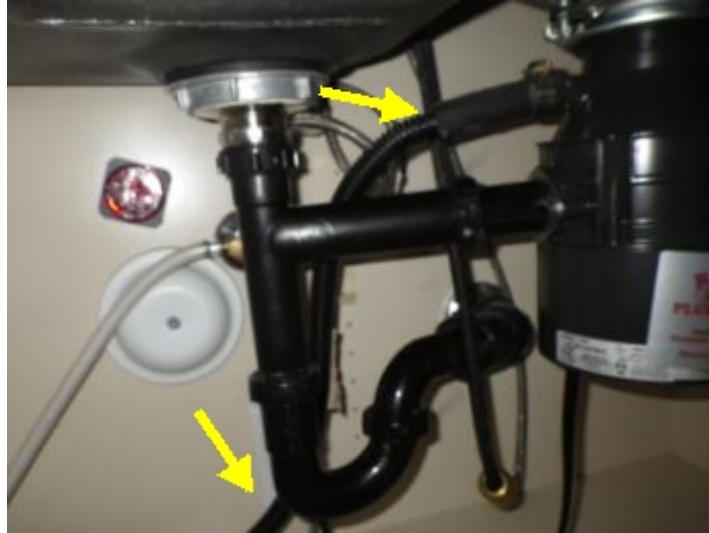
Cross connection- Lack of a proper high loop or air gap noted at dishwasher drain line.

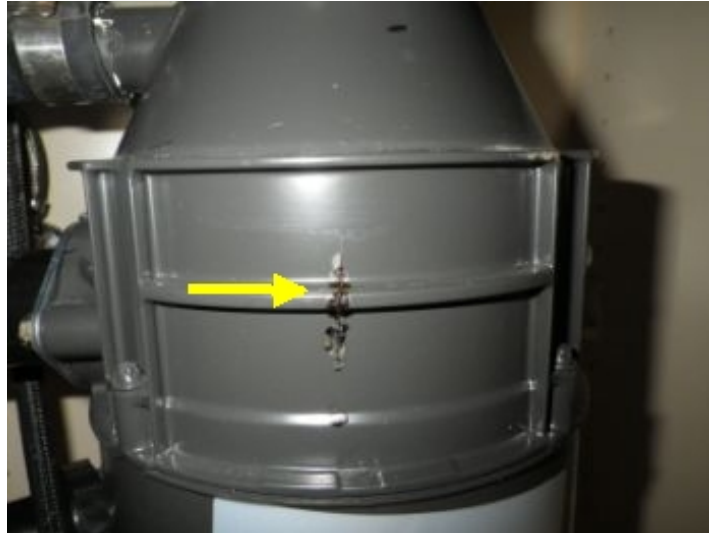
Garbage Disposal is corroded and should be replaced before it leaks or fails.

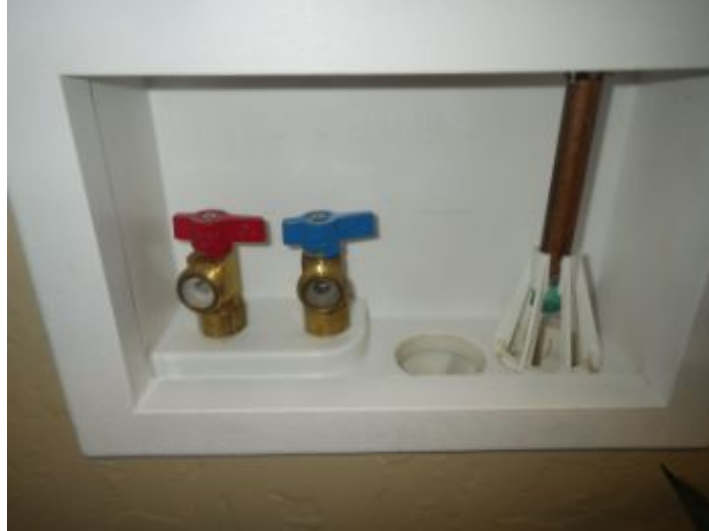
Washer supply valve box appears to be in good condition, the supply valves are not turned on or off.
