Sonoran Property Inspections

Property Inspection Report

7639 E Traders Trail, Prescott Valley AZ, 86314
Inspection prepared for: Jerry Spicer
Inspection Date: 6/10/2016 Time: 9:00 am to 12:30 pm
Age: 2007 Size: 2210
Weather: Cloudy 74 degrees

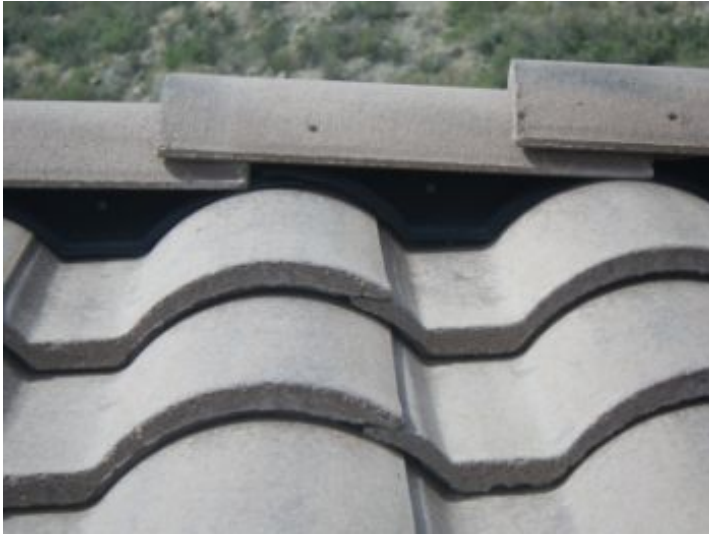
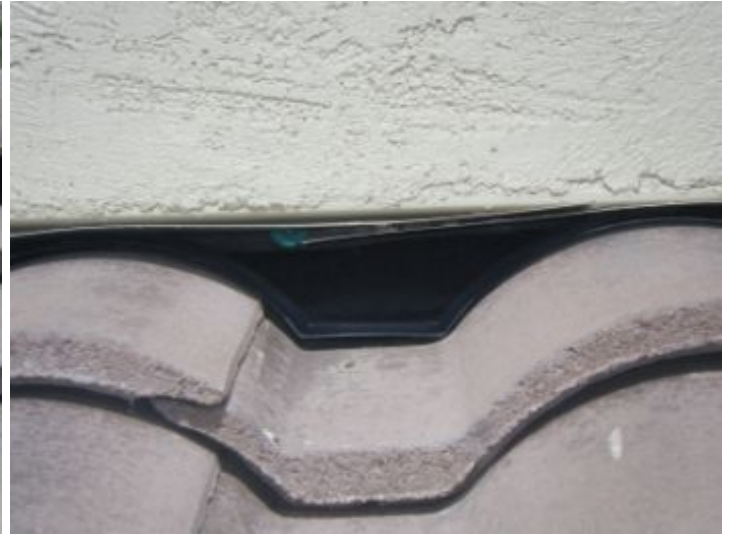
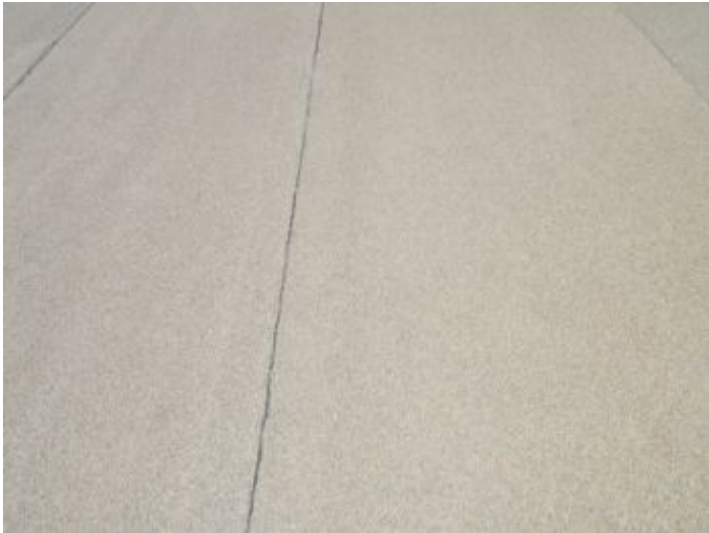
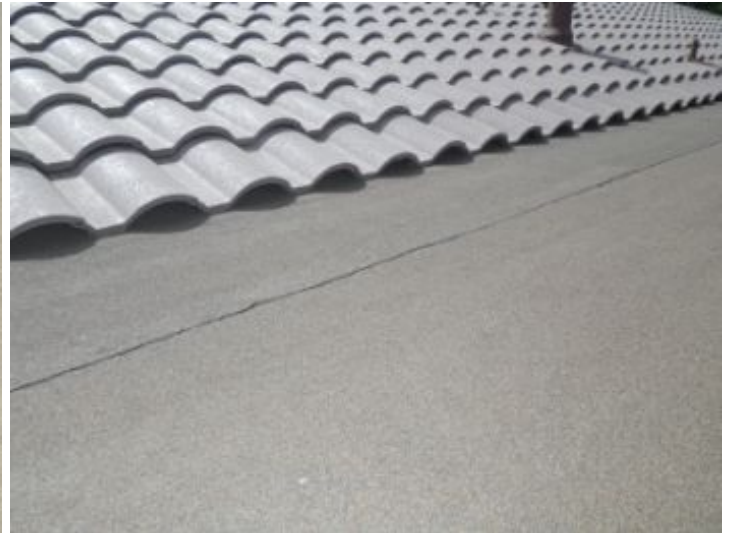
- Estimated Life Expectancy of a Concrete Tile roof is 23-25 years. This of course very dramatically based on weather, rain, sun, attic temps, quality of materials and installation methods. The estimated age of this roof is based on the inspectors opinion and experience, for a more precise evaluation I recommend having a licensed roofing contractor evaluate.
- Estimated life expectancy of Rolled Roofing is 15 to 18 years, This of course can vary dramatically based on the weather, rain, sun, attic temps, quality of the materials and the installation methods. The age of the roof is an estimation based on the inspectors experience, for a more precise accounting of the roof, please consult a licensed roofing contractor.
- Functional /Satisfactory Roof covering- will last 5 or more years depending on maintenance and weather

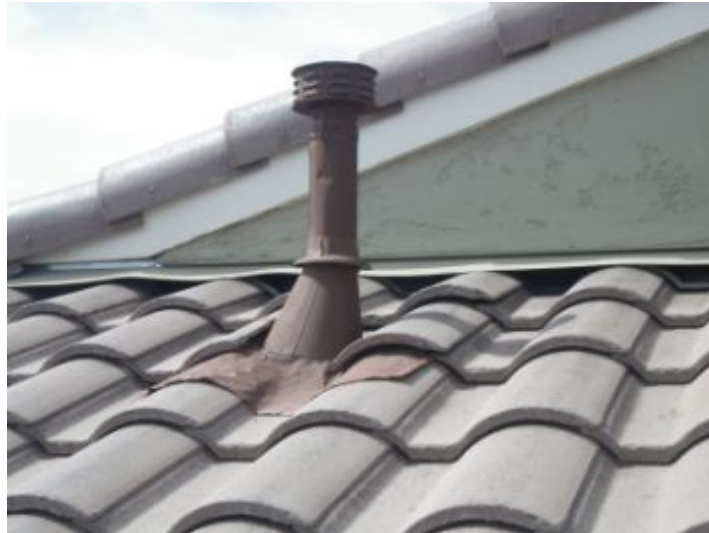
- Spark arrestor is installed and appears to be in satisfactory condition

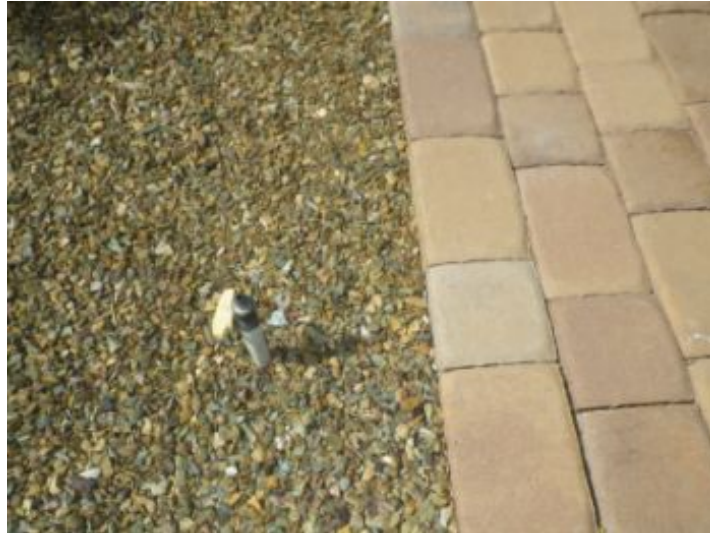
BBQ Stub

- Visible gas piping has support straps present
- Natural Gas present

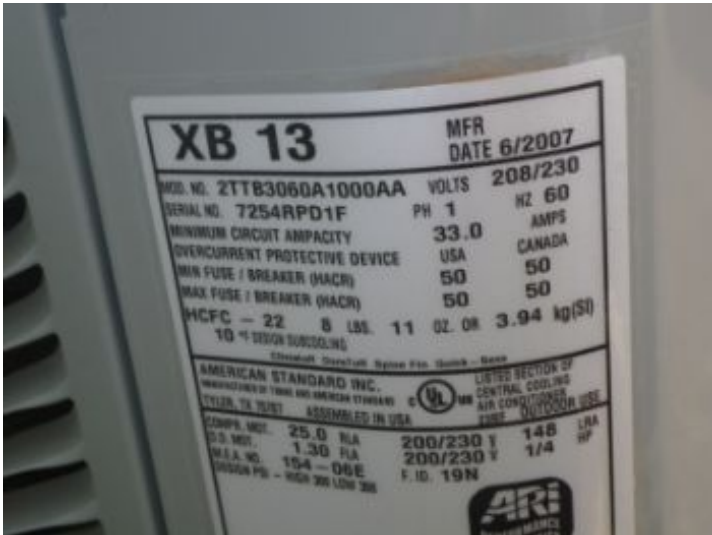
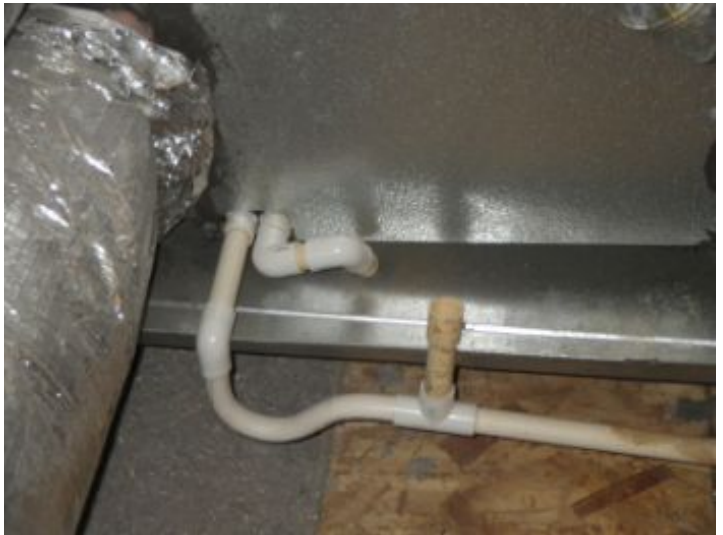
- Electric Air Conditioning has a typical temperature drop between 18 - 22 degrees F between the Supply and Return Air. This system responded and achieved an acceptable temperature drop at the time of the inspection today.

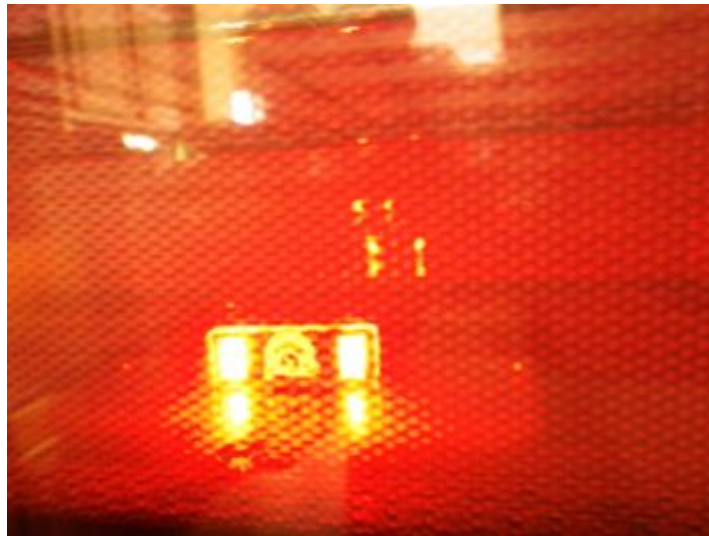
Built-in microwave ovens are tested using normal operating controls. Unit was tested with a microwave light detector and was operational at the time of the inspection. Microwaves can fail at anytime as they are an electric component and the most likely failure is the Magnetron. This part can be replaced yourself for about \$140 and is generally warranted for about 10 years.

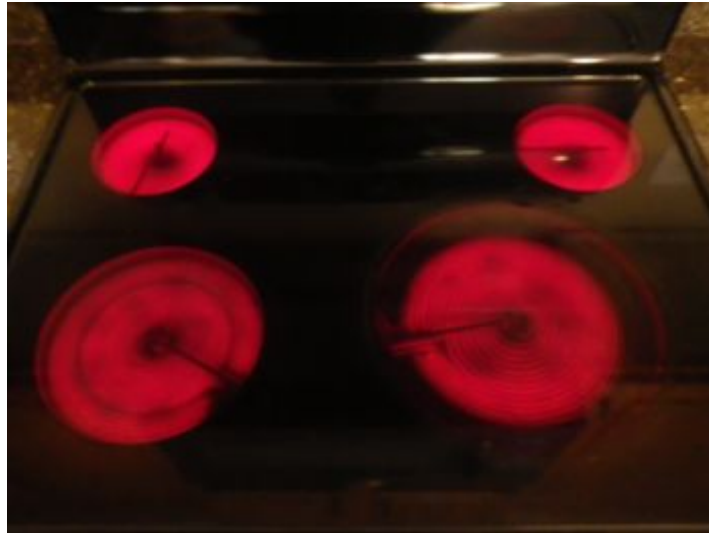
This Cooktop was tested and appeared serviceable at time of inspection. Inspection does not include calibration as this is not a technically exhaustive inspection. No warranties or guarantees for this or any other appliance is offered. Appliances can fail at anytime and is impossible to predict when.

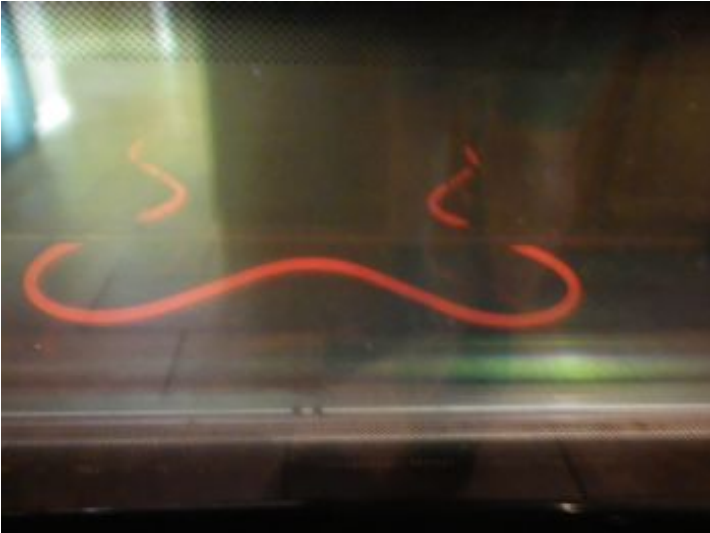
The Electric oven was tested at the time of inspection and appeared to function properly. These can fail at anytime without warning. No warranty, guarantee, or certification is given to safe guard against future failure. Appliances can fail at anytime and is impossible to predict when.

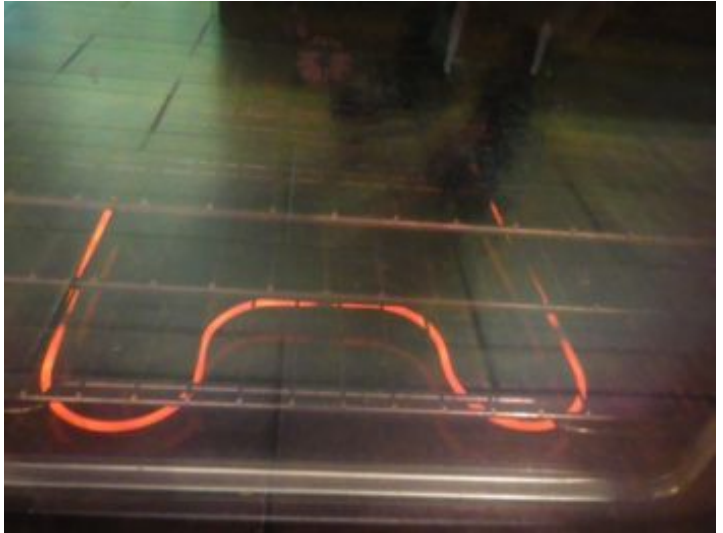
The Electric oven was tested at the time of inspection and appeared to function properly. These can fail at anytime without warning. No warranty, guarantee, or certification is given to safe guard against future failure. Appliances can fail at anytime and is impossible to predict when.

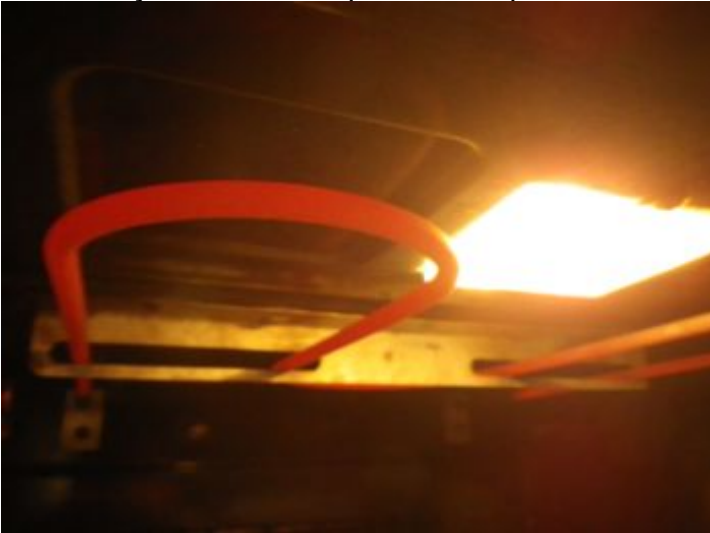
The Electric oven was tested at the time of inspection and appeared to function properly. These can fail at anytime without warning. No warranty, guarantee, or certification is given to safe guard against future failure. Appliances can fail at anytime and is impossible to predict when.
